Inspection reference: 190067

Confidential Inspection Report

734 Juniper Lane
Some Where US 65014

January 19, 2019

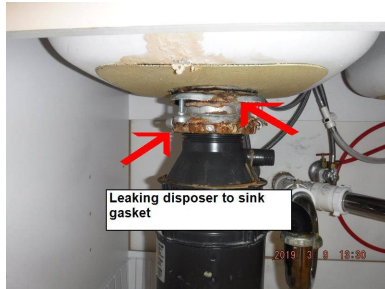
Attention Needed - The sink or drainage gasket needs attention. There was evidence of a leak.

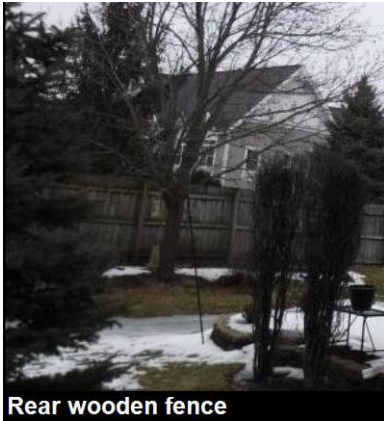
Rear wooden fence

Wood materials used for fencing. The fence is constructed using 6-foot boards. Is a common fence with the HOA.

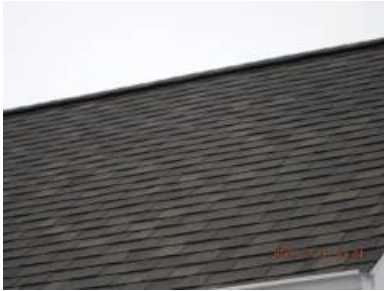
Fiberglass composition shingles. Fiberglass mat, asphalt impregnated. Shingles are applied in horizontal rows.

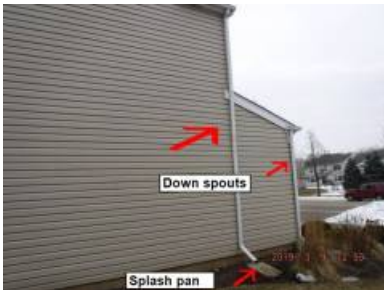
The gutter system on the roof edge appears to be functional and adequately sloped to carry the water to the downspouts.

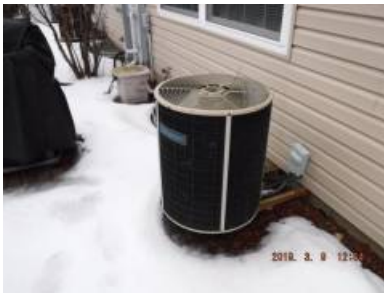
System is Comfortmaker. Model # AD024GD Serial number is L931362490. Manufacture Date April 1993. **Attention Needed - Although this unit was operational during the inspection, the age and/or condition is such that you may need to replace it in the near future.**

Refrigerator/Split System. Electricity-powered. Condenser unit Location- Rear of building.

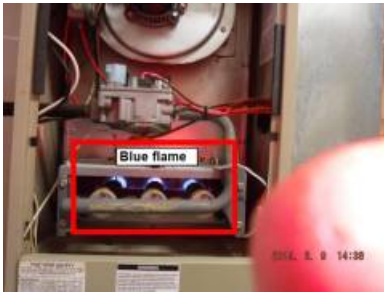
Manufactured in 1993. **Attention: Although operational at the time of the inspection, the age and/or condition of this unit is such that you may need to replace it in the near future.**

Unit was operational at the time of inspection. General condition appears serviceable Nice Blue Flame.

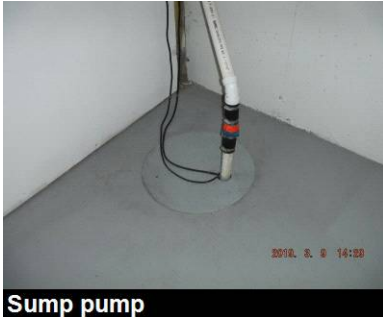
Yes - The sump pump installed is functional. The presence of a sump pump does not indicate there is a need for it. This inspection does not verify the existence of or effectiveness of any subslab or perimeter drainage system. There is a submersible type sump pump installed.

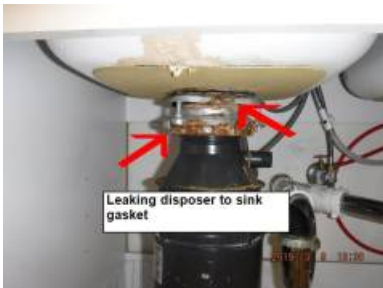
The sink and drainage lines appear to be functional. **Attention Needed - The sink or drainage gasket needs attention. There was evidence of a leak.**

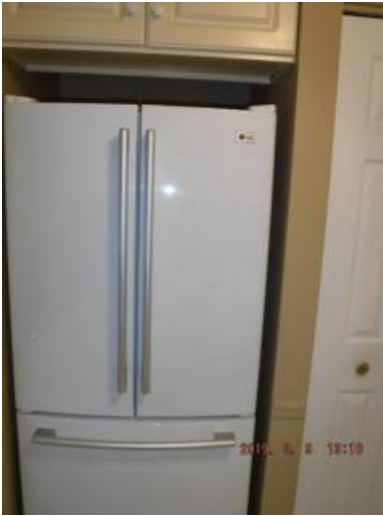
System is LG. Model # LRFC22750SW Serial number is 60MRTT00065. **Action Necessary** - The refrigerators ice maker does not make ice cubes. Further investigation is needed to determine if repairs or replacement of ice maker need to be done.
